Jura Impressa X7

Strip & Clean

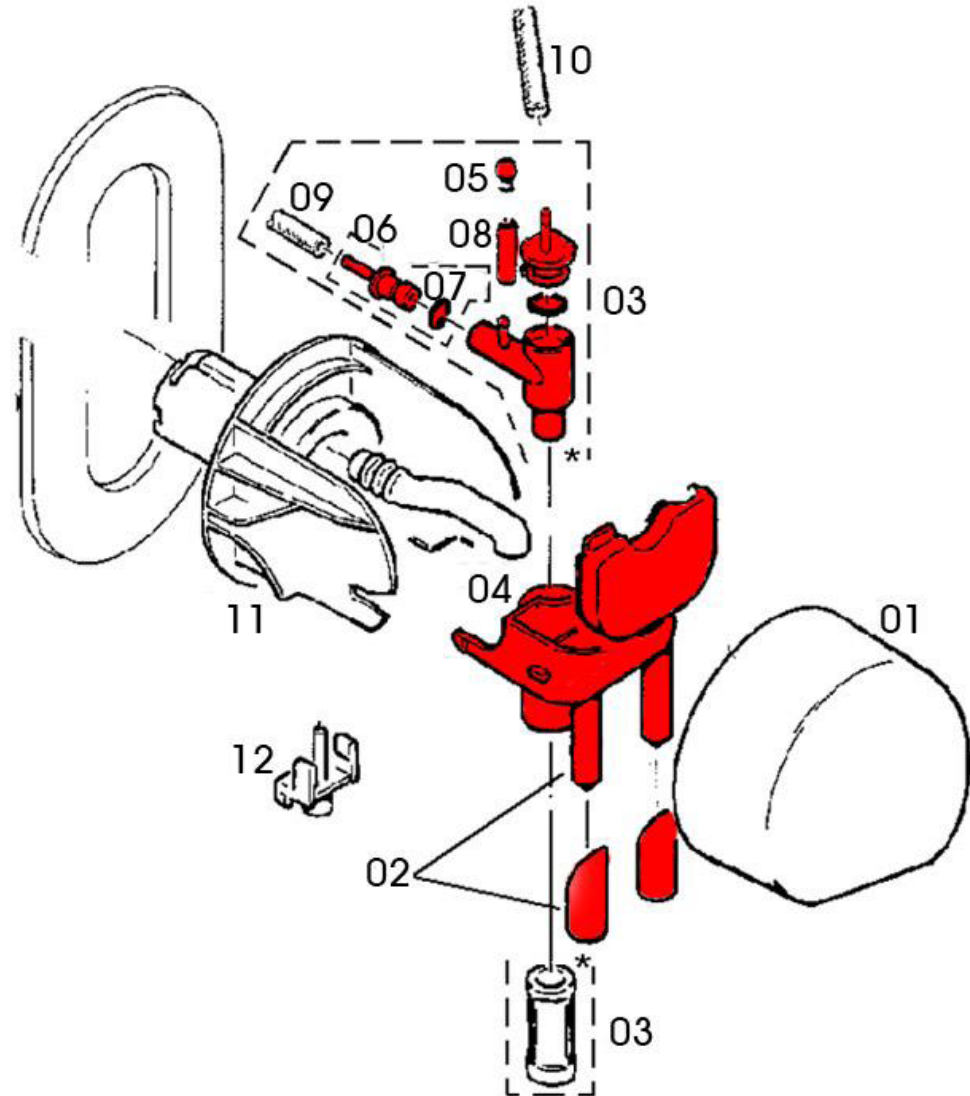
- Carefully remove cap 01 by pushing release button 12
- Remove pieces 02 – 08 (marked in red) and soak in strong solution of cappuccino cleaner (50:50) for around 30 mins
- Ensure valve 05 is clear. If blocked it can be cleared by pushing a small pin or paper clip down either end. Do not use anything larger than the hole or the part will be damaged.
- Rinse all parts thoroughly in clean water
- Re-assemble as per diagram

<u>KEY</u>	
1	Cap silver
2	Outlet
3	Foam nozzle autocappuccino set
4	Discharge channel
5	Cover cap black
6	Adapter 1.5mm
7	O-ring
8	Silicone hose
9	Milk hose
10	Steam hose
11	Outlet gate support
12	Release button
